# ARMORED FORCE MEDICAL RESEARCH LABORATORY

CARBON MONOXIDE HAZARD FROM AUXILIARY GENERATORS IN TANKS

Project No. 3-12

December 20, 1942

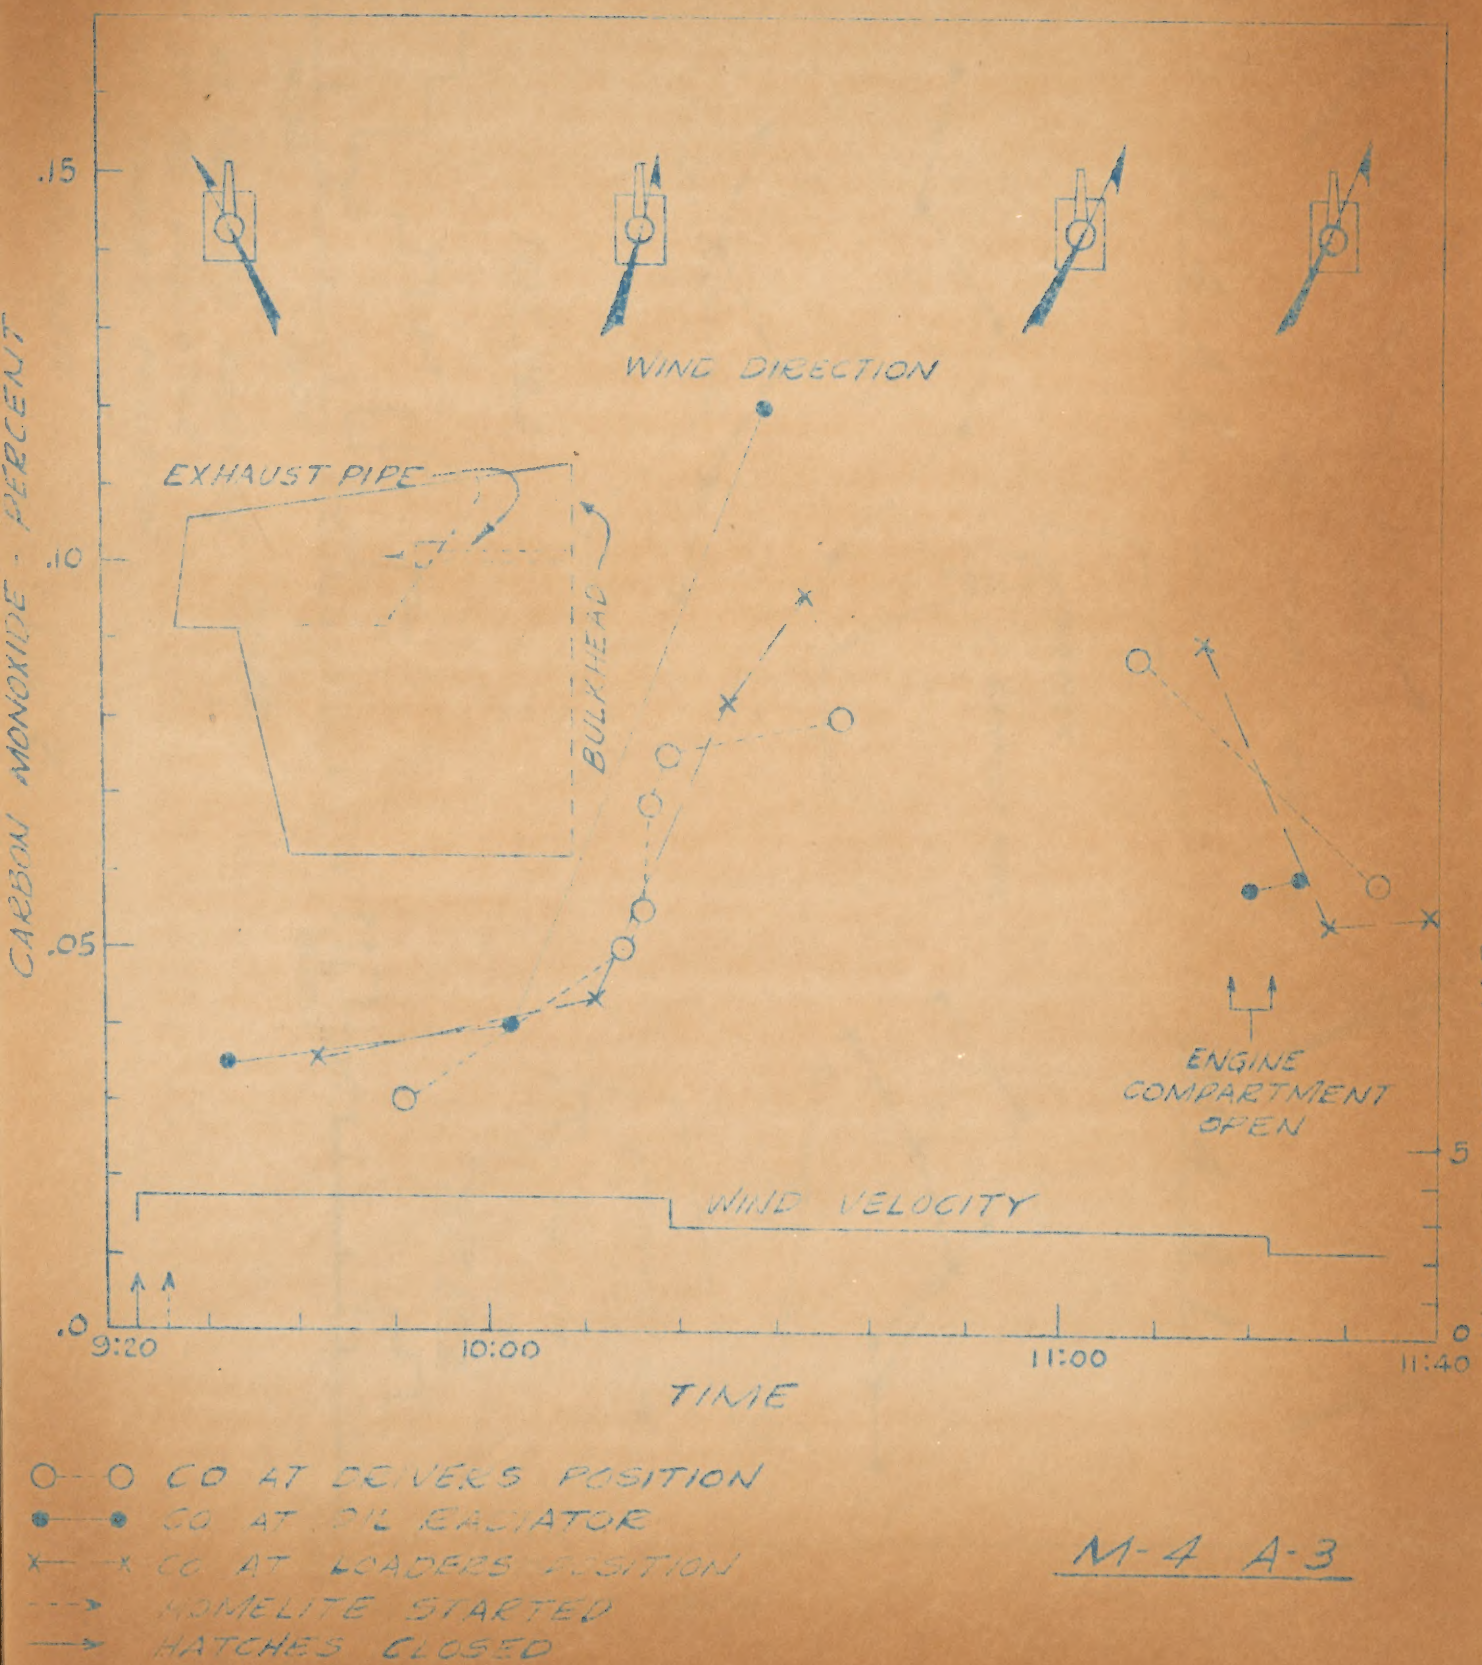
Fig. 1

M4A3 ---- with exhaust pipe terminating within the engine compartment. (Fig. 1)

a. M4A3. Carbon monoxide concentrations are shown in Fig. 1. Concentrations were highest at the radiator, but were found to be greatly in excess of permissible levels in the bow. There was a rapid distribution of the contamination within the tank, with concentrations ranging, during the test, from 0.03 to 0.10 percent carbon monoxide.

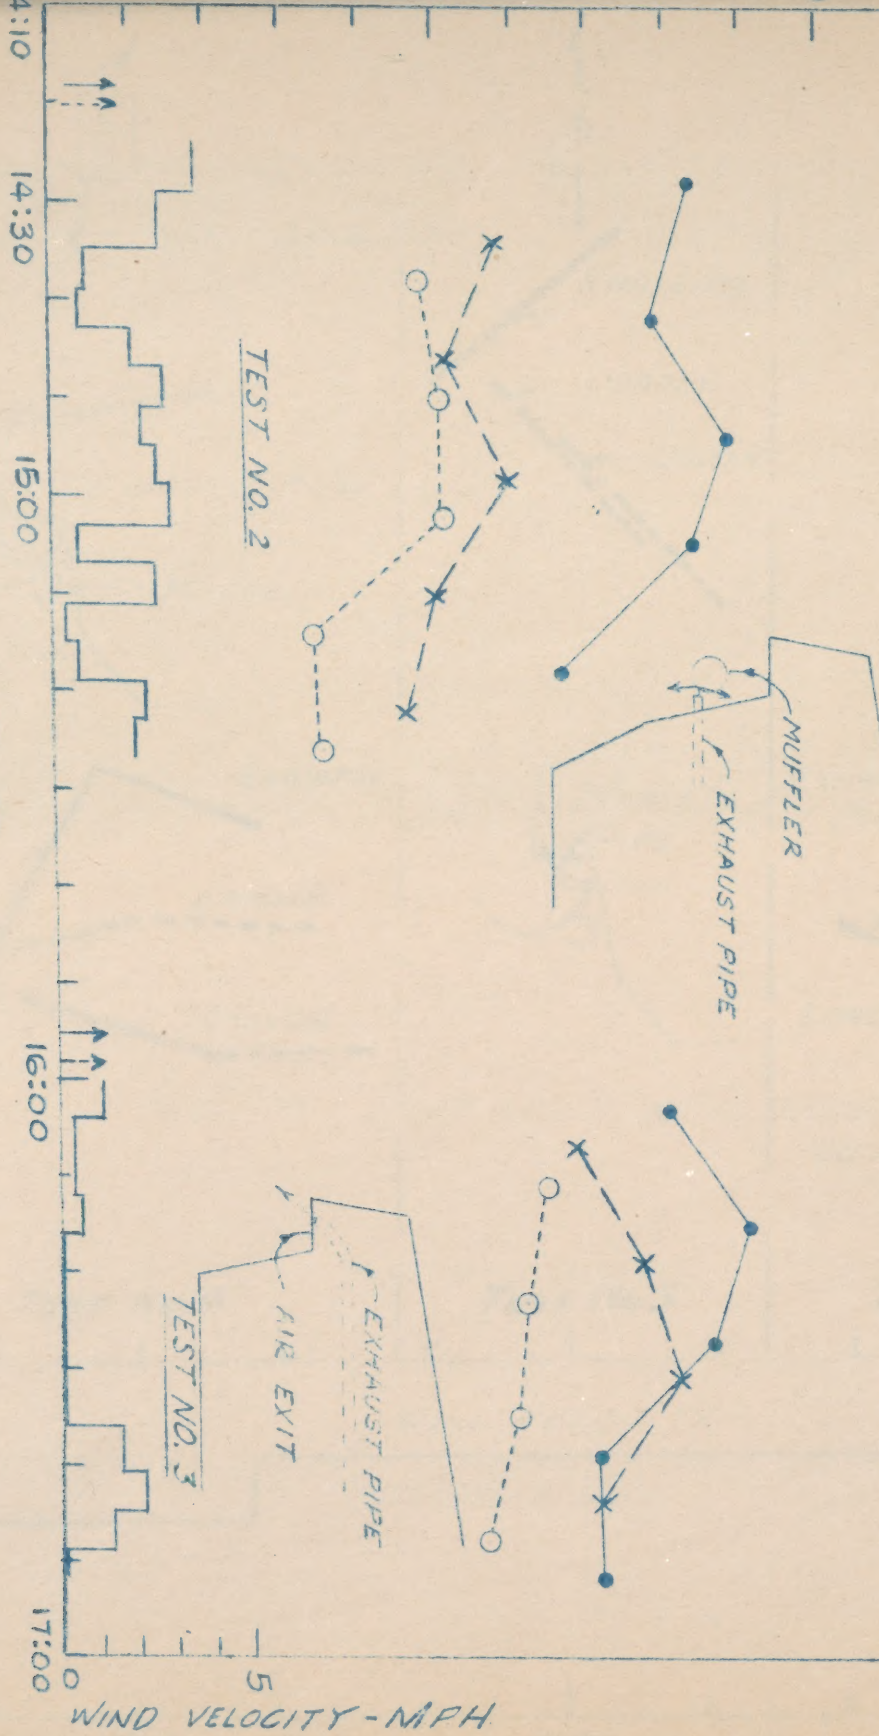
Fig. 2

M4A1 ---- with exhaust pipe terminating in the air-exit area at rear of tank. (Fig. 2)

M4A2 ---- with exhaust pipe terminating outside the rear wall of the engine compartment and between it and muffler. (Fig. 2)

b. M4A2. In this model the exhaust pipe passes through the engine compartment and terminates outside between the rear wall and the muffler. The latter acts as a baffle which deflects the exhaust gases, some of which rise and return into the engine compartment through the main engine radiator and thus find their way back into the fighting compartment. Carbon monoxide concentrations at the three sampling locations are all shown in Fig. 2. The ranges in concentrations under the conditions of test were:

1. Radiator: 0.065 to 0.087 per cent carbon monoxide
2. Loader : 0.045 to 0.060 per cent carbon monoxide
3. Driver : 0.035 to 0.052 per cent carbon monoxide

c. M4A1. The exhaust pipe in this case terminates just inside the armored air-exit opening at the rear of the engine compartment, discharging at a downward angle through the screened opening. Under conditions of a tail wind, the exhaust gases are trapped to a considerable degree and return through the engine compartment to the fighting compartment. Carbon monoxide concentrations are shown in Fig. 2. Ranges in concentrations were:

1. Radiator: 0.070 to 0.090 percent carbon monoxide
2. Loader : 0.067 to 0.083 percent carbon monoxide
3. Driver : 0.057 to 0.063 percent carbon monoxide

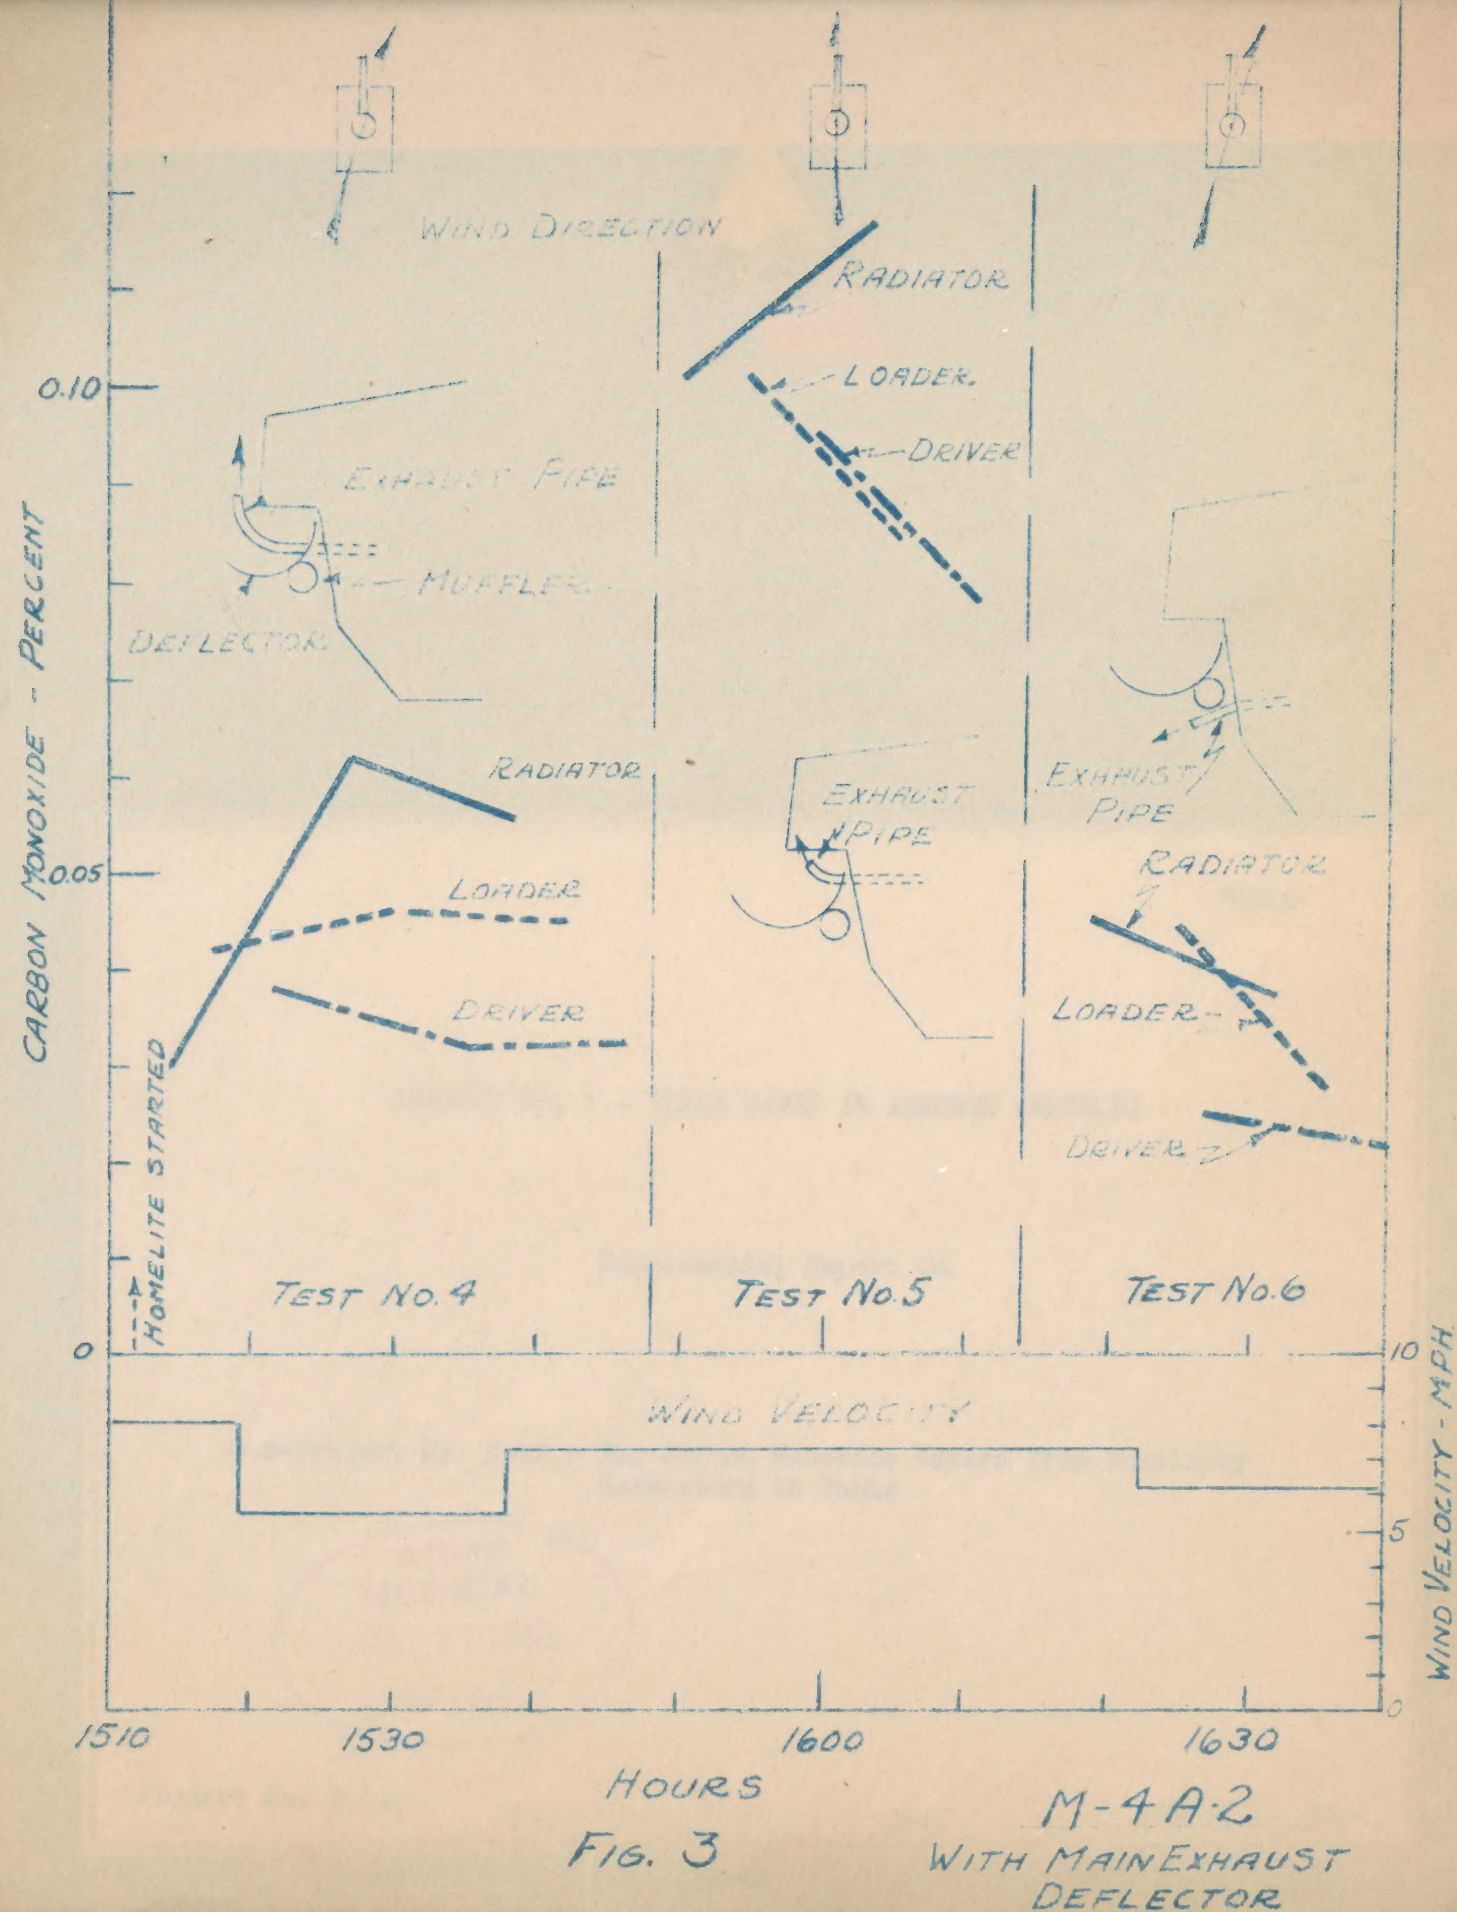
M4A2 ---- with exhaust pipe terminating outside the rear wall of the engine compartment and below the curved baffle plate provided for the deflection of the tank motor exhaust gases. (Fig. 3)

For comparison, carbon monoxide concentrations were determined with the exhaust discharging above the main exhaust deflector at such a point that the gases traveled upward into the overhanging air-exit area. The results are shown in Fig. 3. With the terminal discharge beyond the overhang and in an upward direction conditions were better than in any of the standard tanks but not altogether satisfactory since some of the gas spilled over the top of the engine compartment and down through the main air intake into the fighting compartment. This shows that correction of the situation is not merely a matter of extending the exhaust pipe out through the rear wall. It must discharge finally at a point where there is little possibility of its being carried back into the tank. It is believed that the preferable location is near the bottom of the tank and to one side of the rear wall.

The most favorable results were obtained with the exhaust pipe terminating beyond the rear wall and below the main exhaust deflector plate. The action of the latter was to prevent the exhaust gases from rising directly into the air-exit area at the rear of the tank. It may be concluded that with exhaust deflector plates installed on tanks, no serious problem will arise (for periods of operation of from 1 to 2 hours) with respect to the exhaust gases from the auxiliary generators when the exhaust pipe terminates below the deflector plate.

a. The exhaust pipe from the auxiliary generator should be extended outside the rear wall of the engine compartment and be terminated at a point free from obstruction so that the exhaust is not deflected toward the air intake or exit openings in the engine compartment. The best location is believed to be near the bottom and to the side of the rear wall. (Fig. 3)

b. When a main exhaust deflector plate is provided, the auxiliary exhaust should be located below it and approximately ten (10) inches from the rear wall of the engine compartment.
